DEPARTMENT OF NATURAL RESOURCES
DIVISION OF OIL, GAS AND MINING

RE: Site Inspection, Shamrock Mining Associates, LLC, Blind Stream Mine, S/013/004, Duchesne, County, Utah

Date of Inspection: July 14, 2003
Time of Inspection: 2:40 to 4:30 p.m.
Conditions: Partly cloudy, 70's
Participants: Jeff Keith (operator); John Sather (Pelican Point Mining); Dave Herron and Chauncie Todd (Ashley National Forest); Wayne Hedberg and Paul Baker (DOGM)

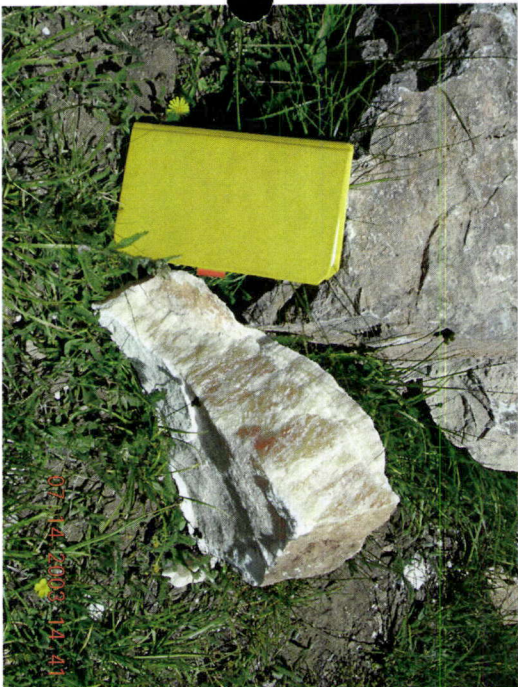
The operator is mining a vein of golden-colored calcite (Photo 1). There is a thin layer of very rocky soil in most places, but the calcite extends to the surface with essentially no soil in others. Some of the dominant plant species in the area include mountain brome; Kentucky bluegrass; slender wheatgrass; yarrow; Louisiana sage; Gordon's ivesia; a currant, probably gooseberry currant; sheep fescue; at least three species of penstemon; Engelmann spruce; and subalpine fir.

Photo 1. The calcite the operator is mining.

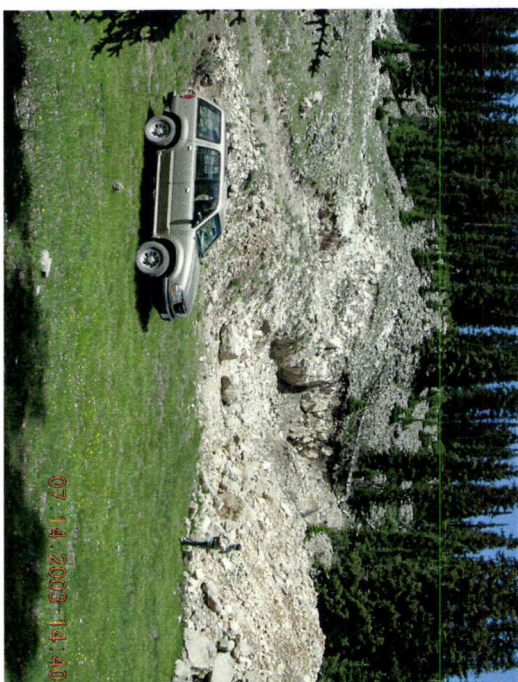
So far, the mine consists of a trench from the bottom of the depression back in towards a hill (Photos 3 and 4). Overburden and waste have been placed on one side of the trench (the right side of Photo 3).

Photo 3. The mine excavation.

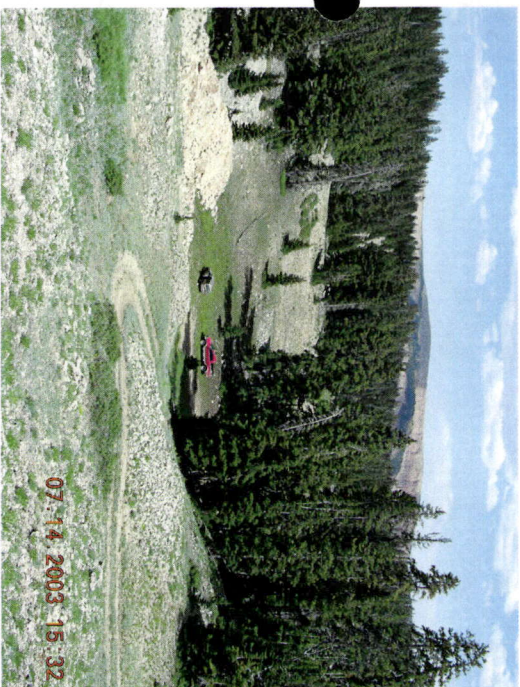
The operator particularly wants to mine larger, unfractured pieces of calcite, and this material tends to be at greater depths. There are two veins in the area of the mine, and they extend for a few hundred feet to the northwest (Photo 2). Also visible in Photo 2 is a depression indicative of karst topography that exists in the area. Partly because of this topography where the water quickly goes underground, there is almost no surface water in spite of the elevation (about 10,600 feet).

Photo 2. View looking back toward the mine (left center) approximately along one of the calcite veins.

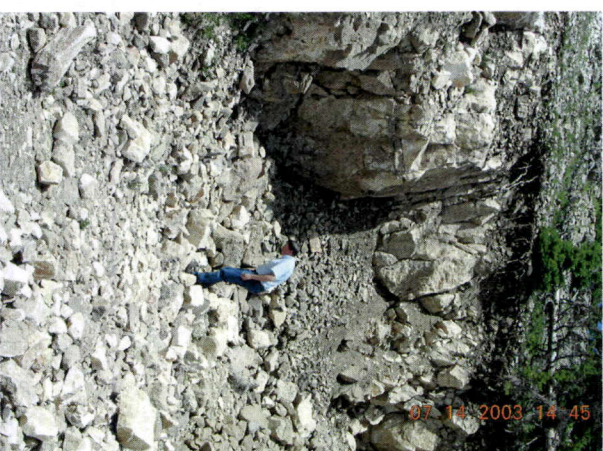
Photo 4. Inside the mine excavation.
